<Reference: 97125289F-FA>

Urgent Field Safety Notice

Subject: Field Safety Notice – Update to December 2024 Field Safety Notice: Software designed to prevent initiation of Safety Mode in an ambulatory setting due to a high battery impedance state in ACCOLADE™ Pacemakers and CRT-Ps (Boston Scientific Reference: 97125289F-FA).

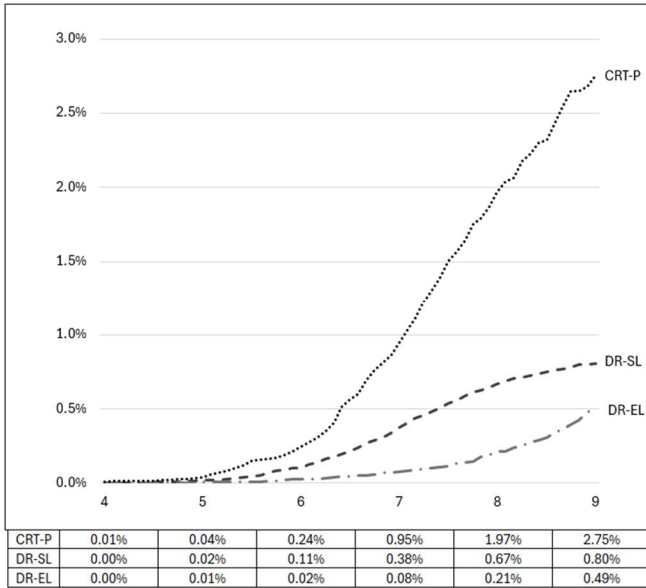
The worst case reported patient harm has been loss of pacing with serious injury or life-threatening outcome. There have been two (2) deaths in pacemaker-dependent patients after initiating Safety Mode in an ambulatory setting and no additional deaths have been reported. Details about the ACCOLADE subpopulations and lifetime occurrence rate for each device type are reported in Table 2. Occurrence rates for various device types are reported in Figures 1 and 2.

Figure 1 Occurrence rates for high battery impedance induced Safety Mode in the December 2024 advisory population

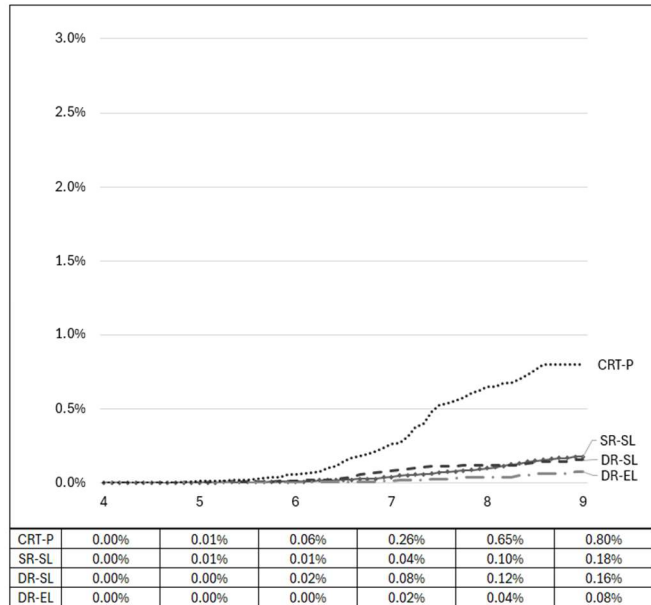
Figure 2 Occurrence rates for high battery impedance induced Safety Mode in remaining devices
